RECLAMATION

Managing Water in the West

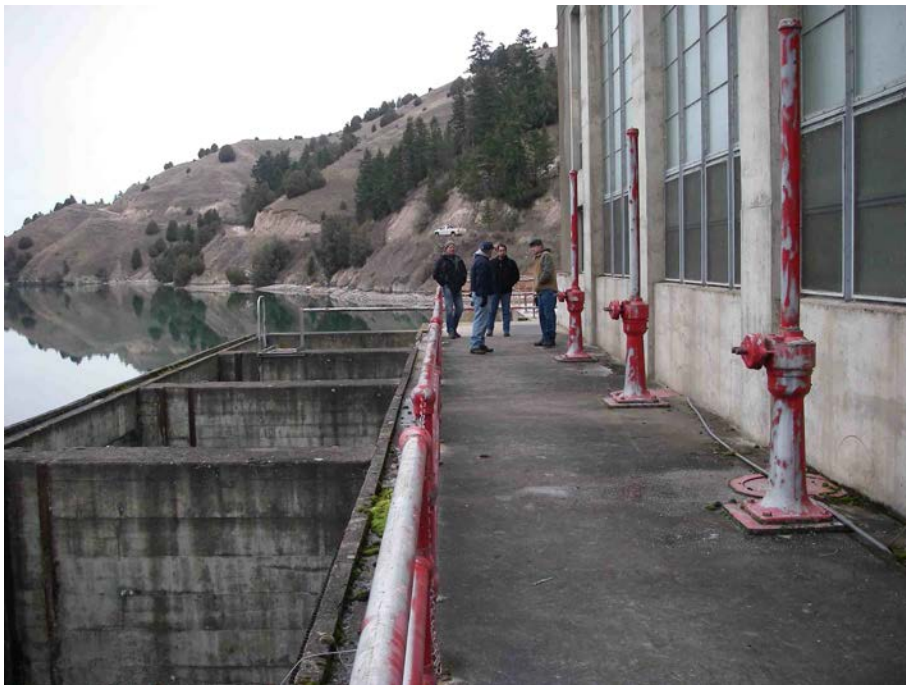
Photograph 4: Looking left across the top of the Flathead Lake Pumping Plant intake structure.

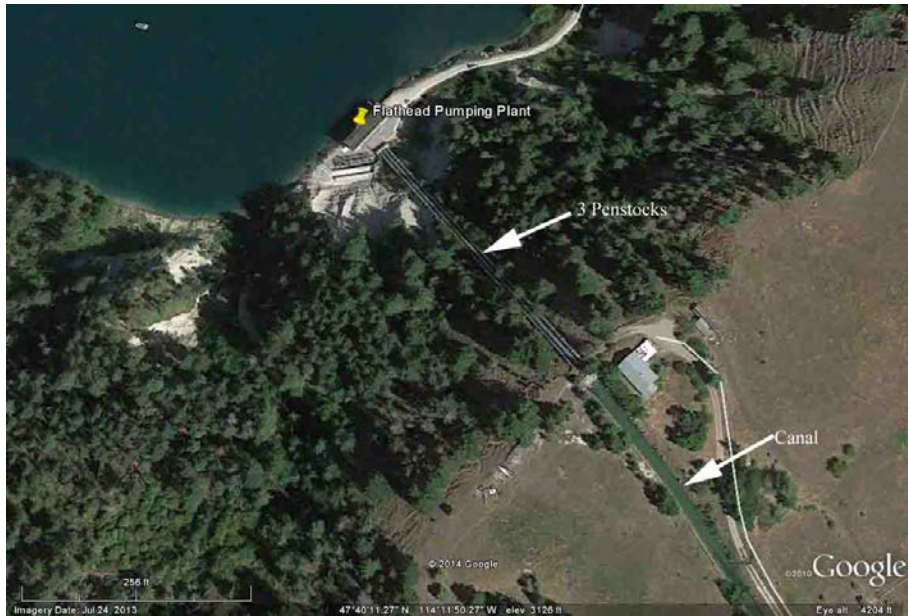
Photograph 5: Aerial photograph of Flathead Lake Pumping Plant, three discharge penstocks, and the canal.

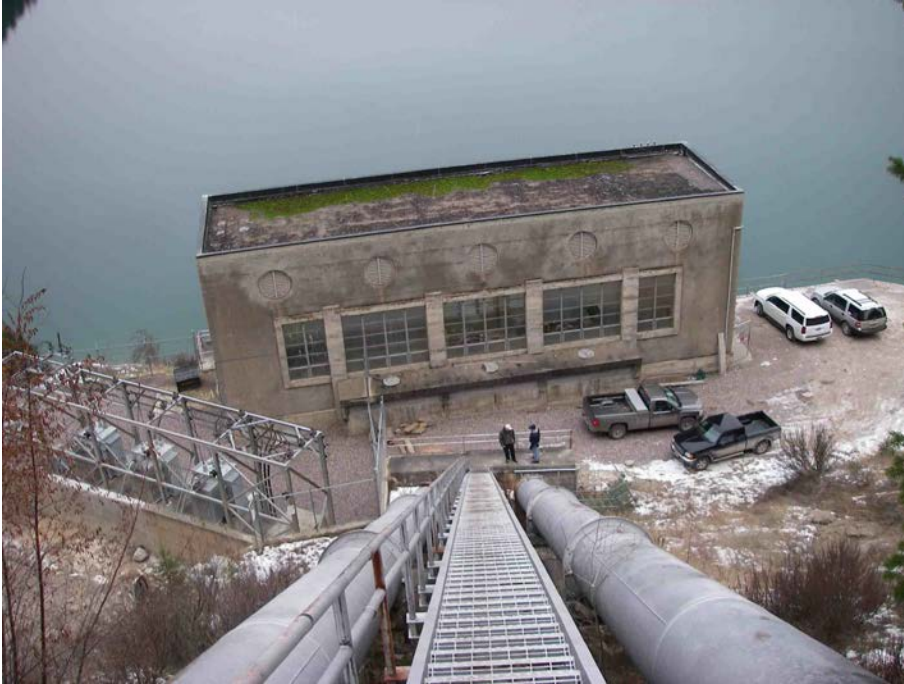
Photograph 6: Looking down the penstocks at the downstream side of the Flathead Lake Pumping Plant building.

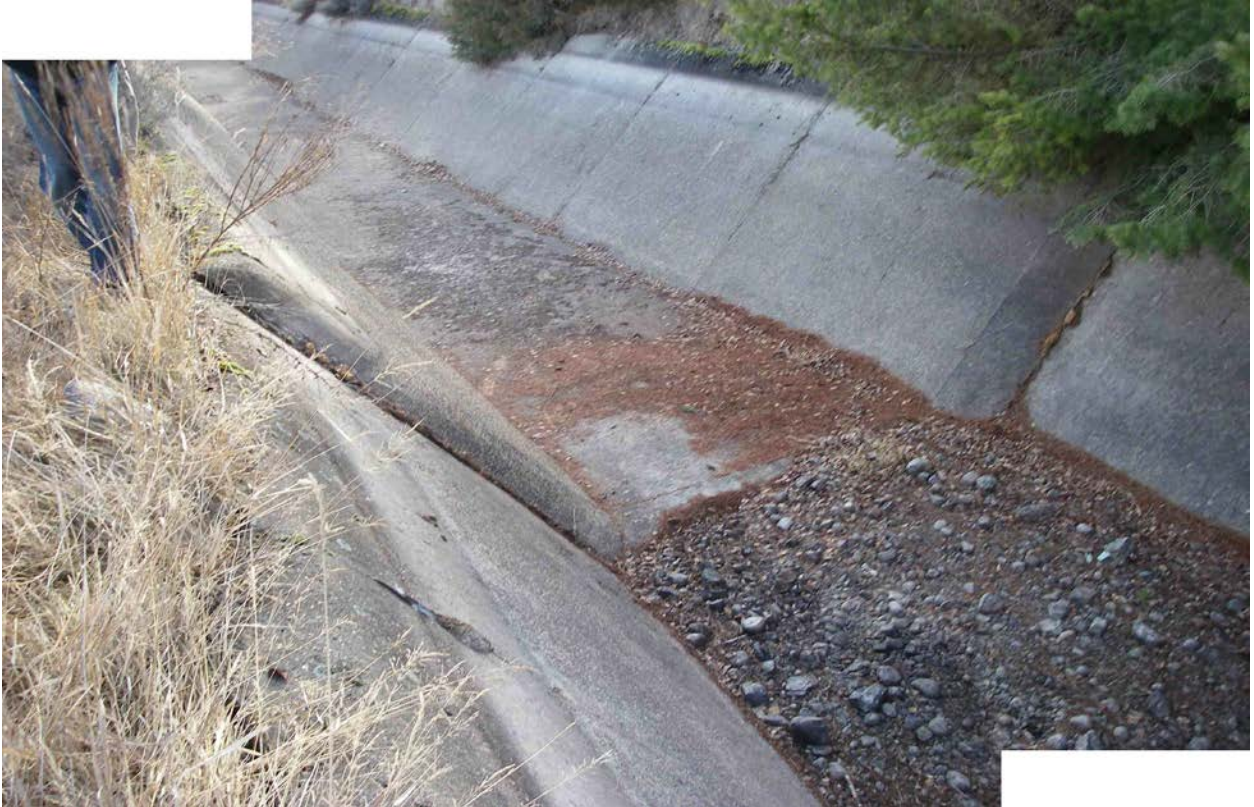
Photograph 8: Looking at the portion of the canal from the Flathead Lake Pumping Plant with a second concrete liner.

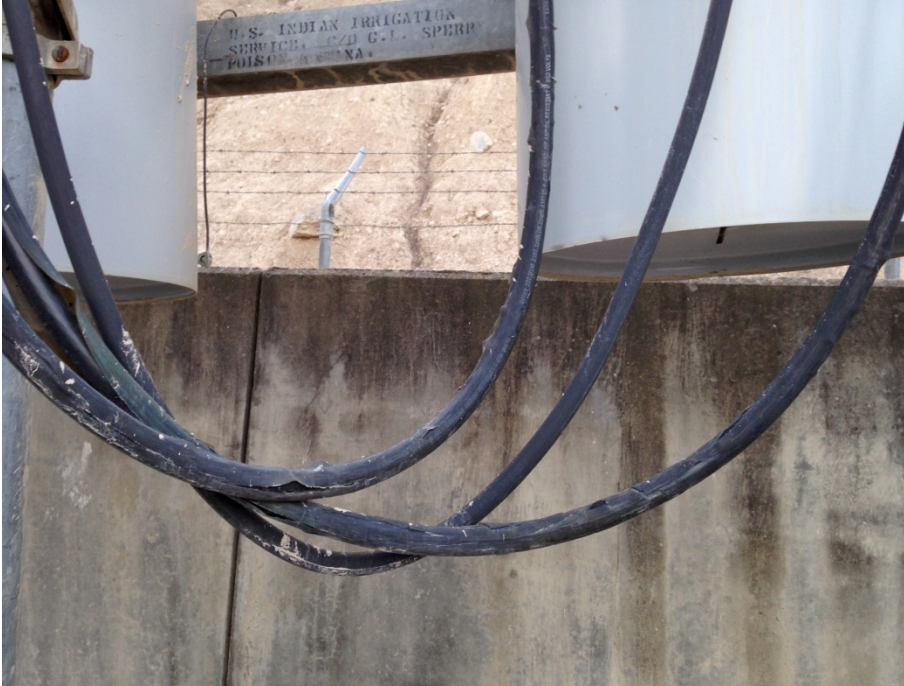
Photograph 13: Photo shows deterioration of cables in substation.

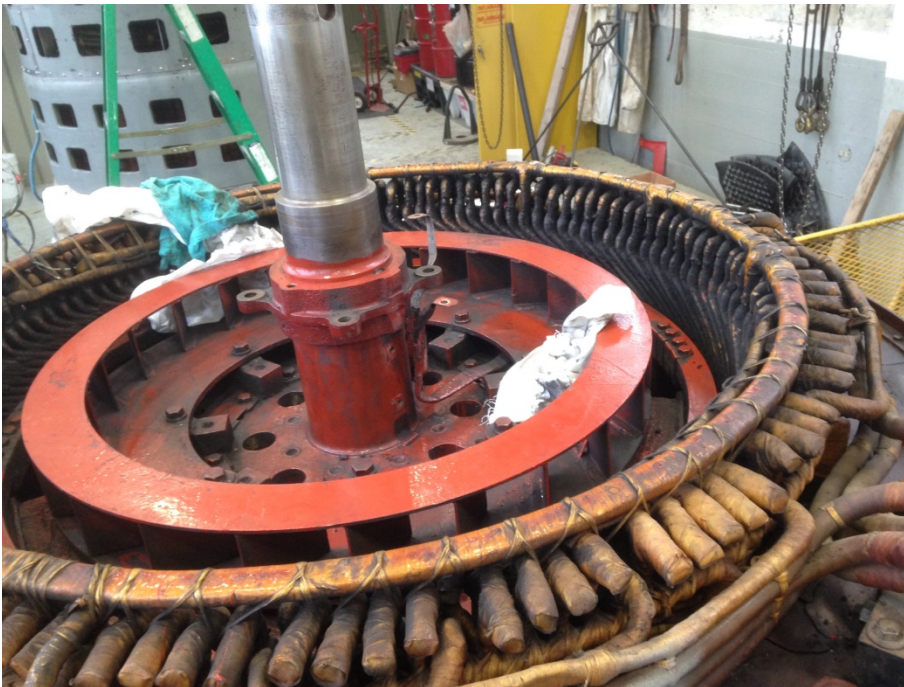
Three Elliott Co. Ridgeway Works synchronous motors, each rated at 3,000 horsepower, 2,300 volts, and 900 revolutions per minute (rpm) drive Worthington centrifugal pumps located in the lower gallery. At the time of the site visit, Pump No. 2 was down for major repair on the motor brush assembly due to arcing of the assembly to ground.

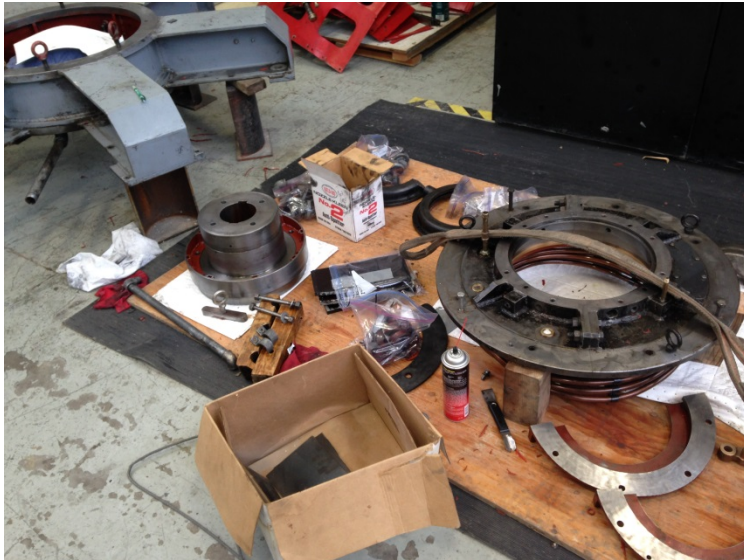
Photograph 15: Flathead Lake Pumping Plant brush assembly and upper bearing parts.

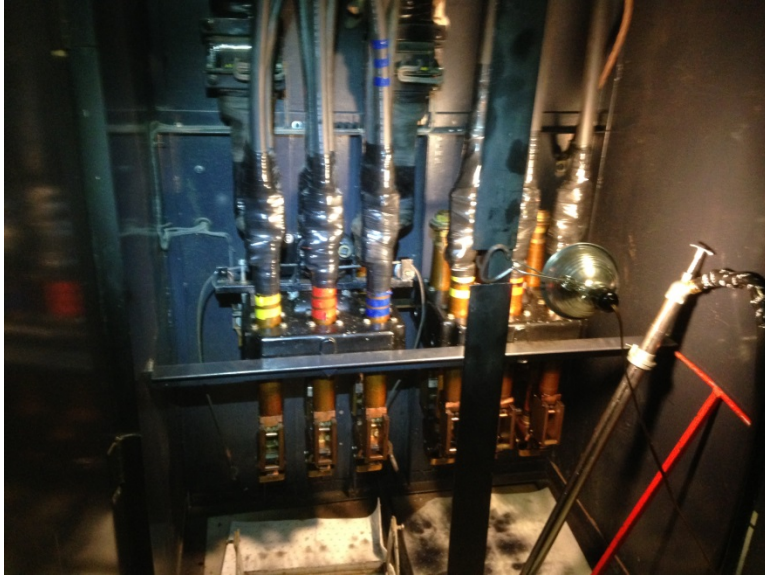
Oil appears to be leaking, requiring recharge of the oil level.

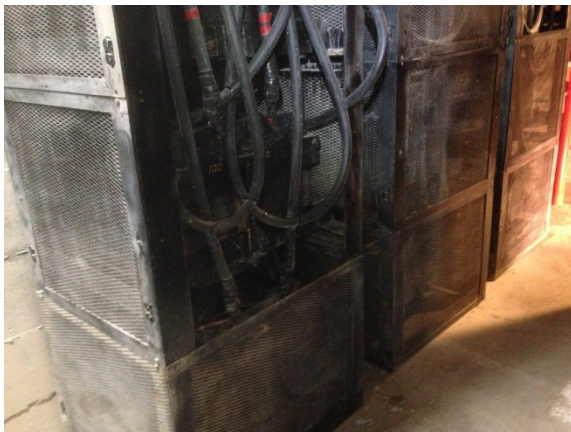
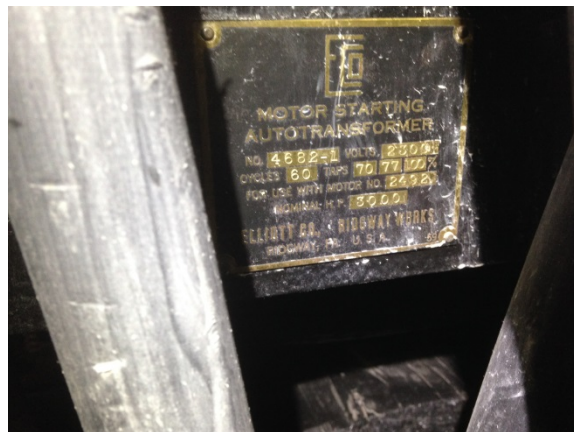
Photographs 20 and 21: Flathead Lake Pumping Plant autotransformers.

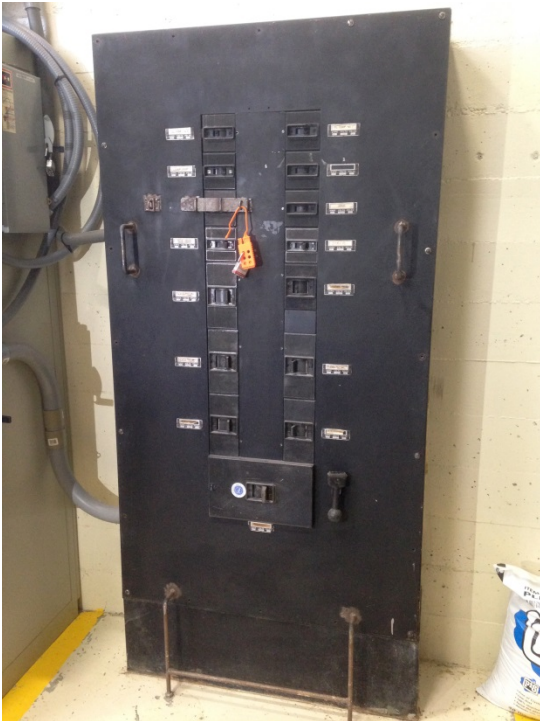
The station service breaker panel near the building exit is in poor condition. Several of the breaker actuation tabs are broken and must be switched on or off with a screwdriver. This breaker panel should be considered as hazardous to plant personnel. The panel should be upgraded with a new enclosure and all new circuit breakers.

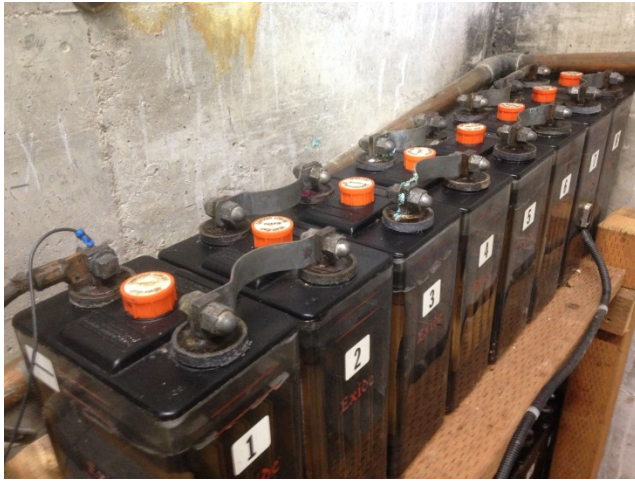
Photograph 23: Flathead Lake Pumping Plant station service battery system.

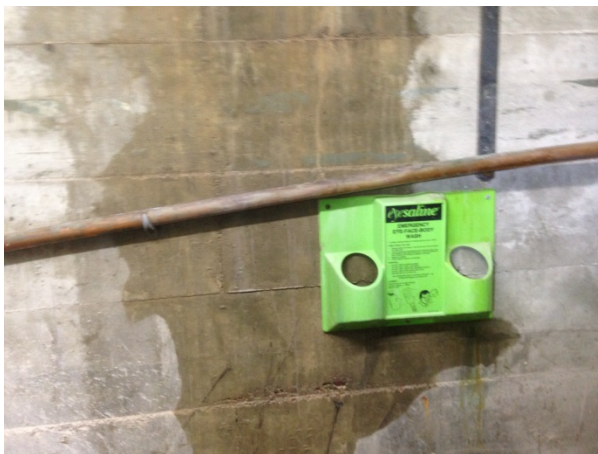
Photograph 24: Looking at missing PPE near the station service batteries.

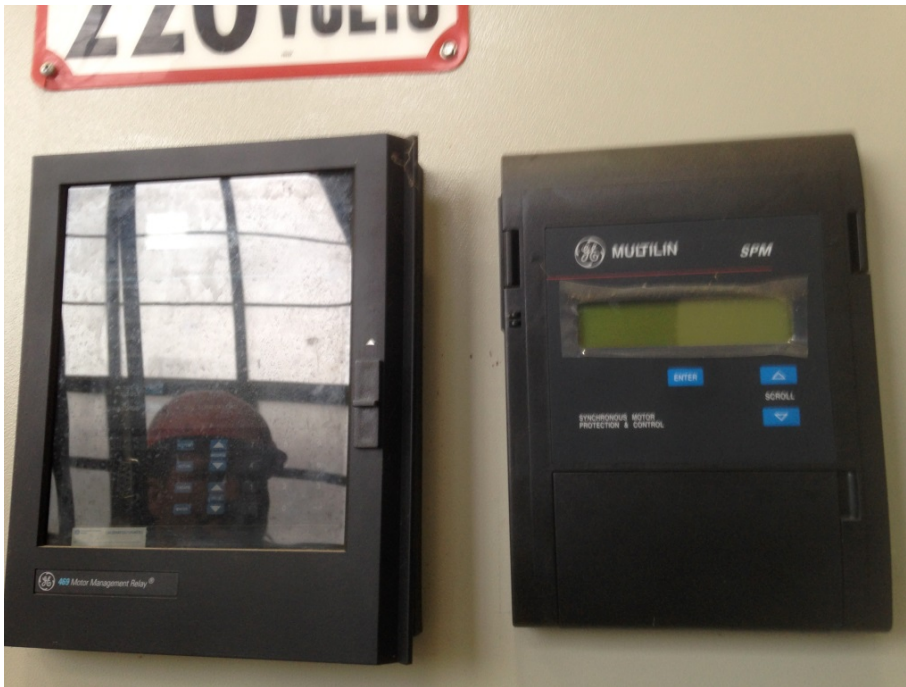
Photograph 25: Flathead Lake Pumping Plant synchronous motor excitation system (Multilin).

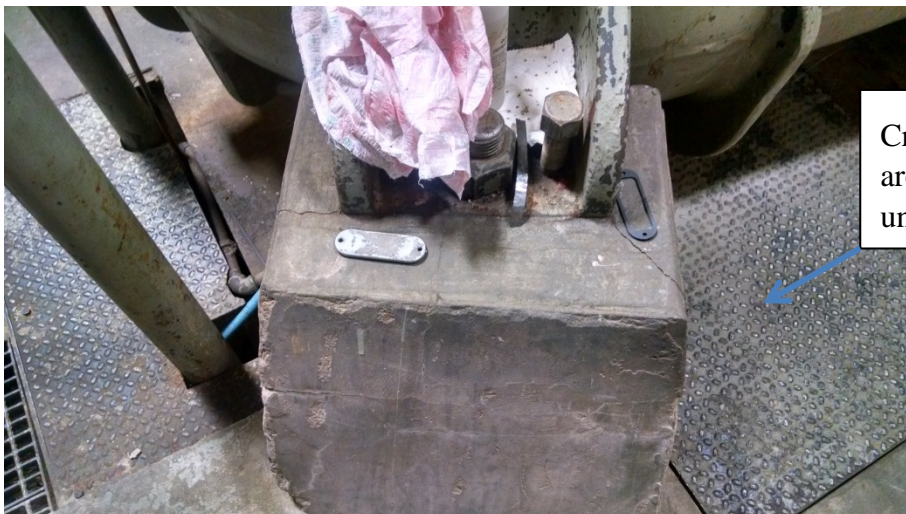
Photograph 28: Cracks on Unit 3 pump mounts.

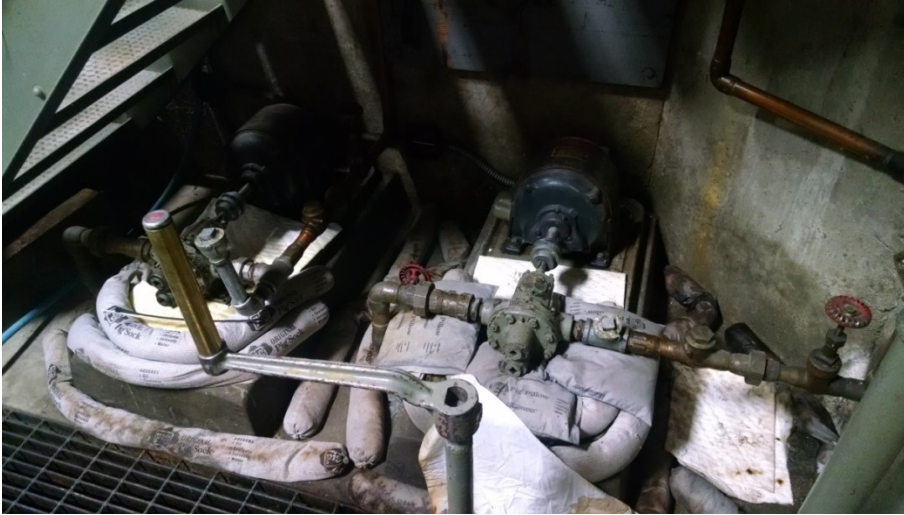
Photograph 29: Bearing Oil Pumps.

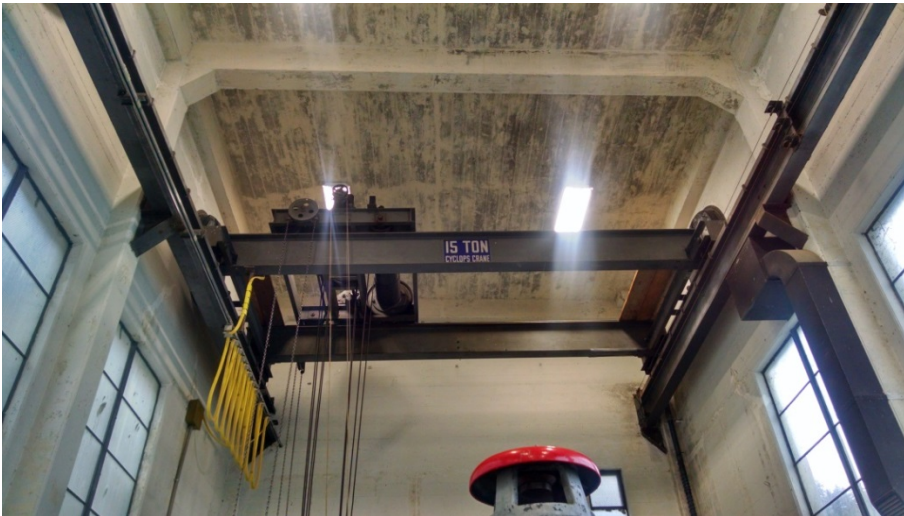
Photograph 30: Flathead Lake Pumping Plant crane.

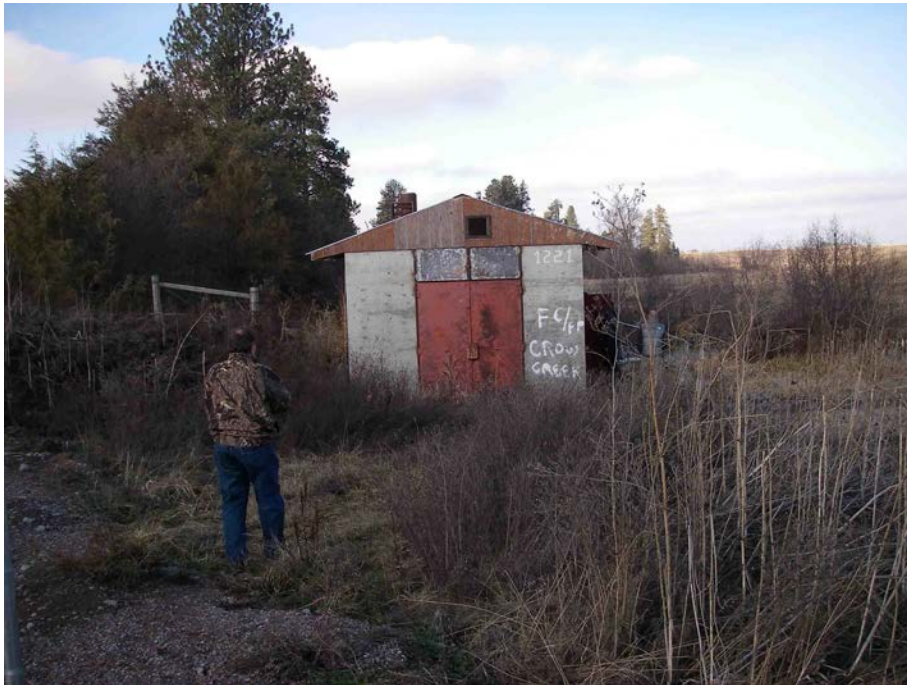
Photograph 31: Crow Pumping Plant building.

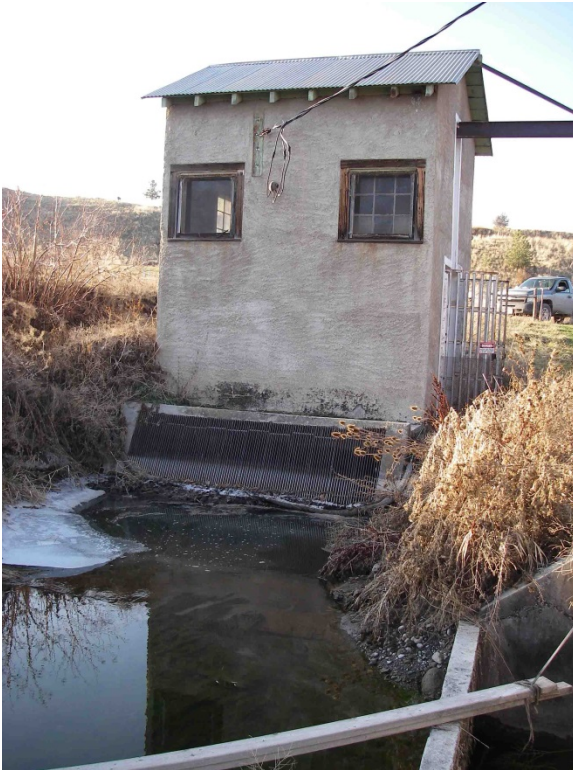
Photograph 35: Reavis Pumping Plant building and intake structure.

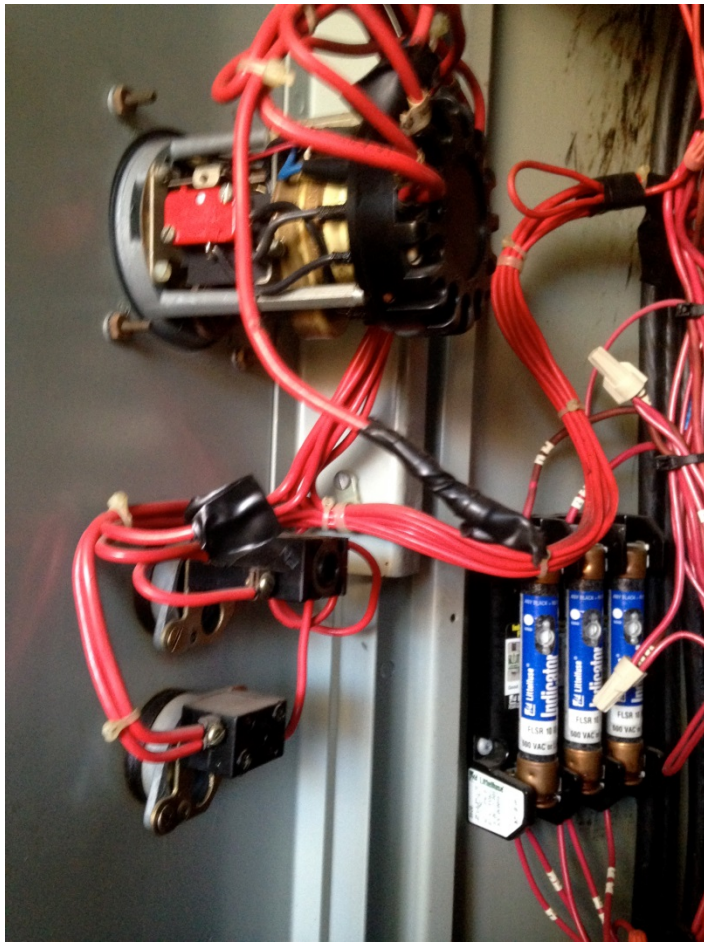
Wires that have been taped off. Timer function is disabled.
