# **An Examination of Home Destruction**

## **Roaring Lion Fire** Bitterroot Mountains, Montana

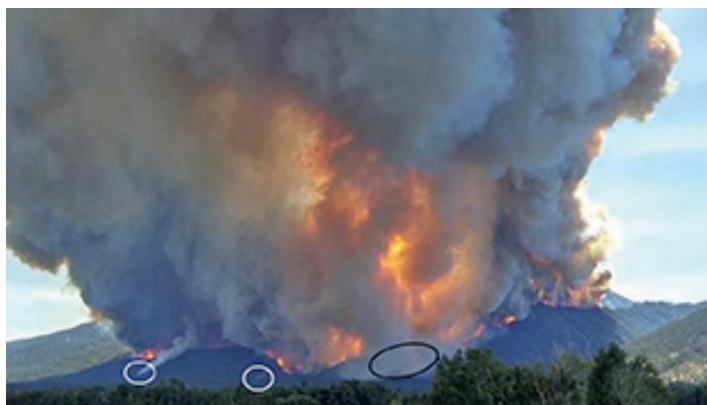
Figure 1. This is the Roaring Lion Fire on July 31 as it spreads eastward and down slope to approach the residential areas near the base of the slope. Significant sections of the flaming front is high intensity crown fire and showering an area downwind with firebrands. The white ovals identify firebrand ignited spot-fires. The black oval identifies an area of down draft that rapidly resulted in spreading spot-fires seen after the smoke cleared.

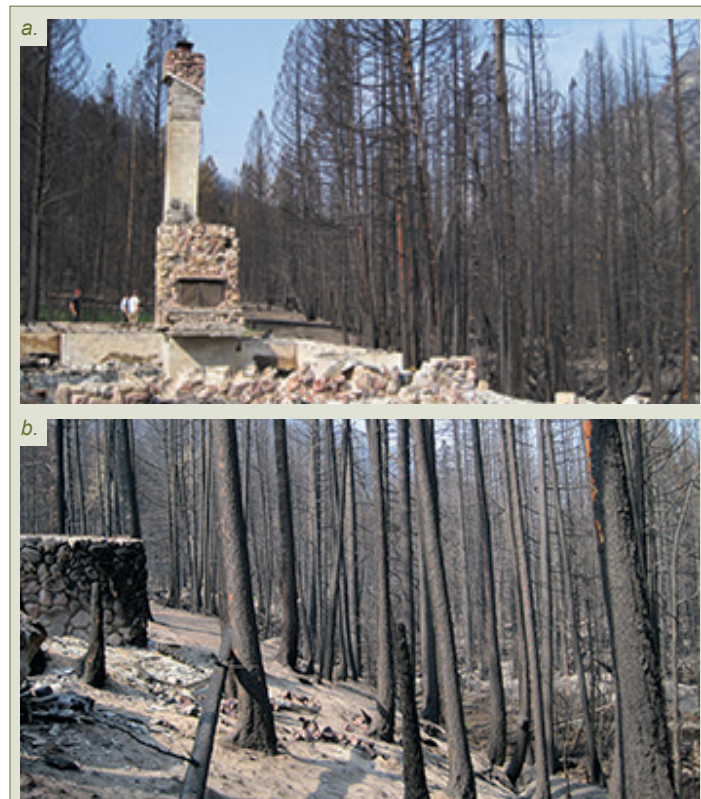
Figure 2. ACTIVE CROWN FIRE. These two separate but associated houses, a) and b) were several hundred feet apart. Both of these structures were 30 feet or closer to active crown fire.

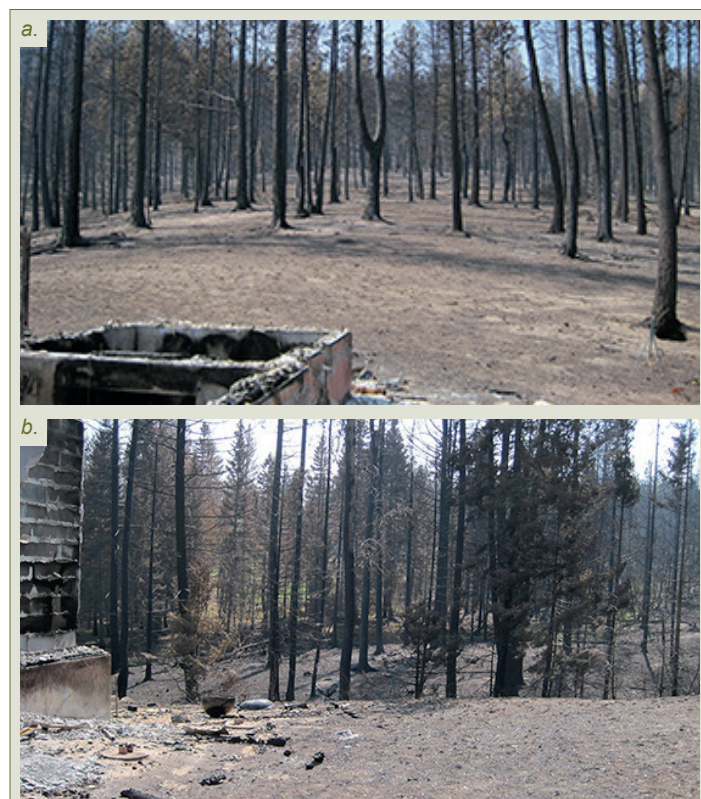
Figure 3. PASSIVE CROWN FIRE. Photos a) and b) are two different views from the same house. The incomplete canopy consumption indicates individual tree torching with brief passive crown fire in the background. The house was more than 60 feet from high intensity burning but note the complete consumption of continuous surface fuels leading to the house.

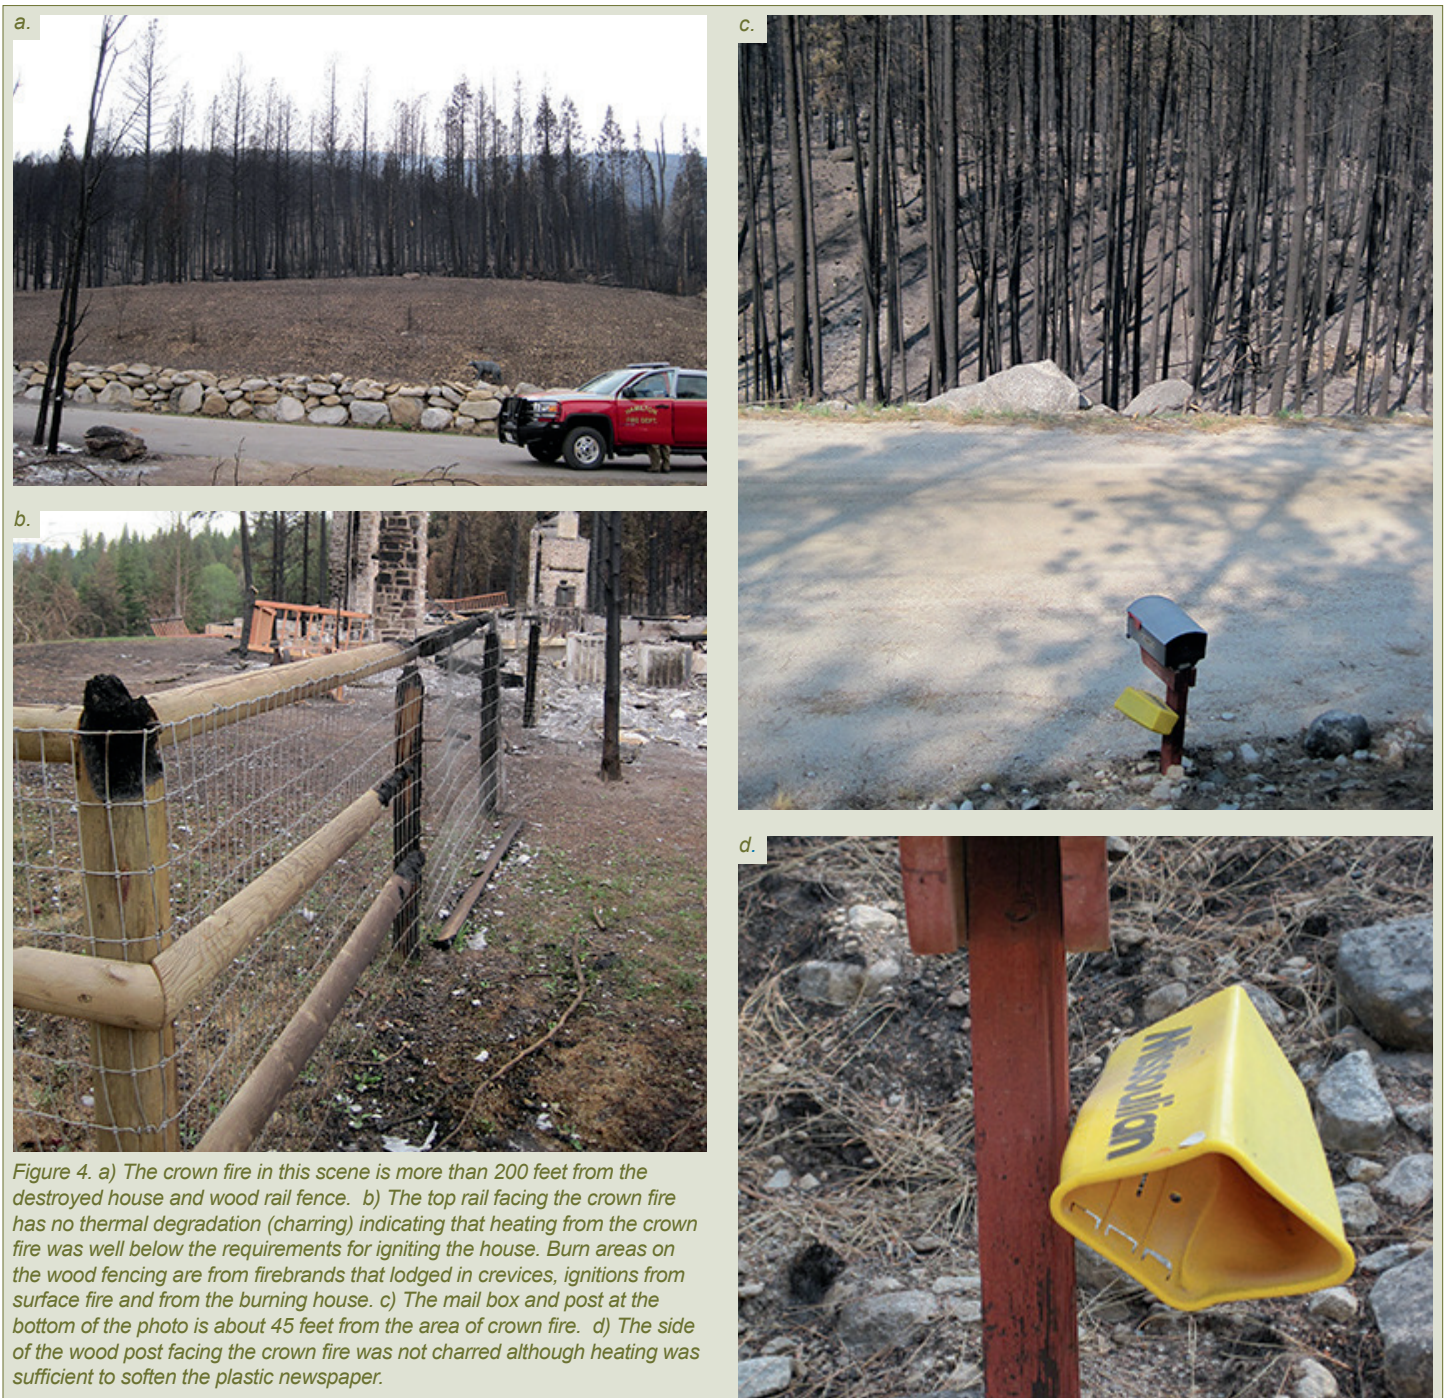
Figure 4. a) The crown fire in this scene is more than 200 feet from the destroyed house and wood rail fence. b) The top rail facing the crown fire has no thermal degradation (charring) indicating that heating from the crown fire was well below the requirements for igniting the house. Burn areas on the wood fencing are from firebrands that lodged in crevices, ignitions from surface fire and from the burning house. c) The mail box and post at the bottom of the photo is about 45 feet from the area of crown fire. d) The side of the wood post facing the crown fire was not charred although heating was sufficient to soften the plastic newspaper.

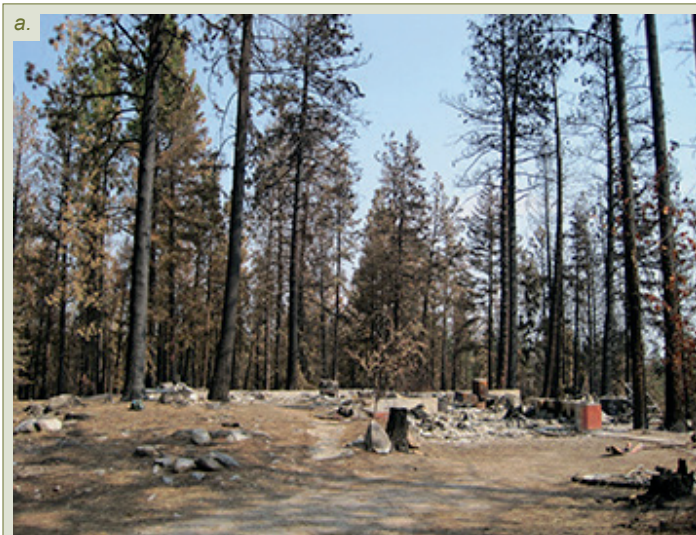
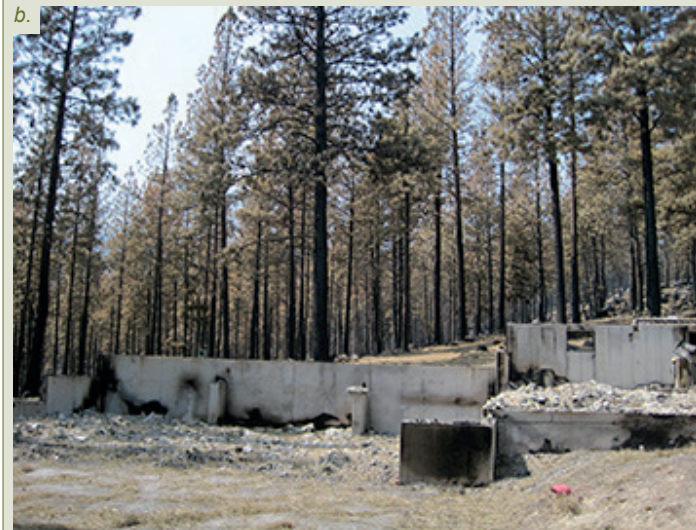
Figure 5. Two different houses a) and b). Neither house had adjacent high intensity burning. The charred and partially consumed trees adjacent to the houses burned from the burning house. The a) house did not have forest fuel treatment; the b) house had forest fuel treatment.

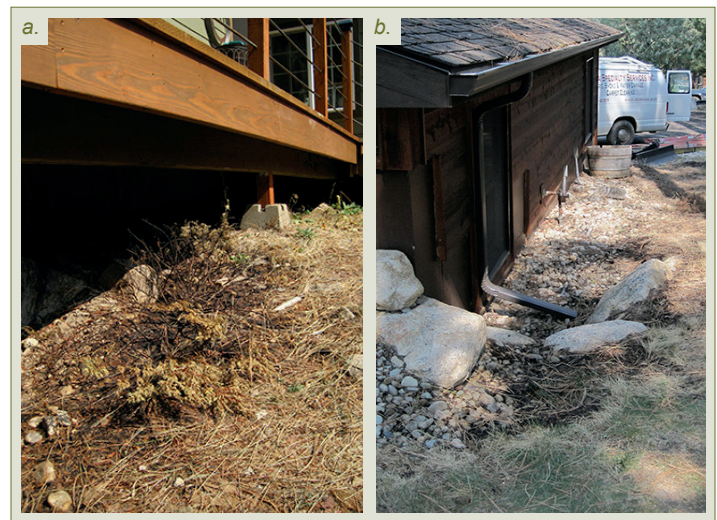
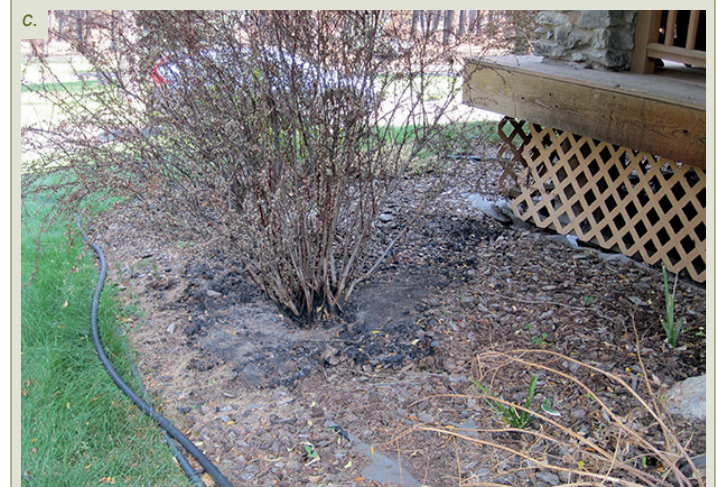
Figure 6. Three examples (a, b and c) of spot-fires ignited by firebrands. Each of these spot-fires demonstrate how important the house and its immediate surroundings are to the home ignition potential. It could not be determined if firefighters extinguished the spot-fires and prevented home ignitions.

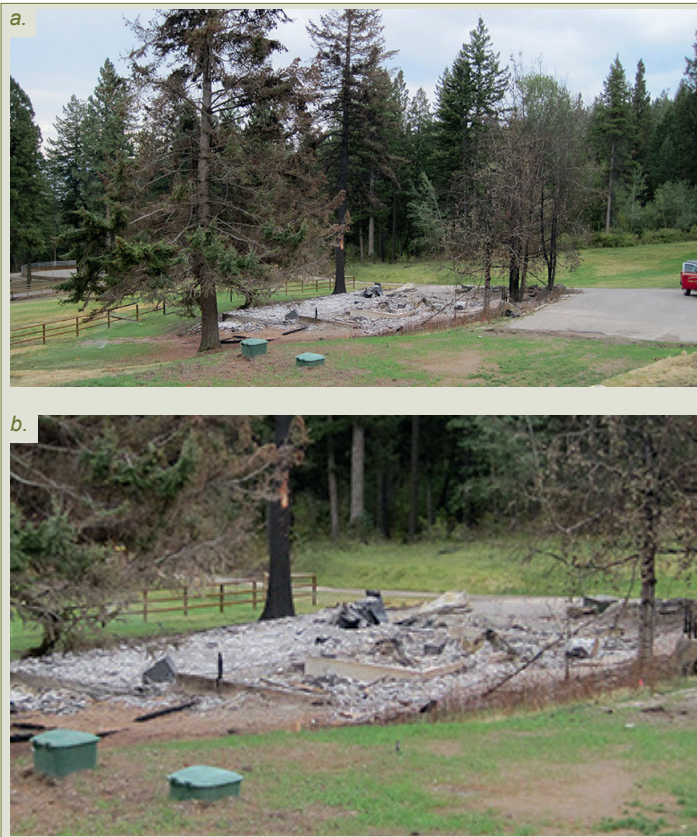
Figure 7. a) A wider view of the destroyed structure and surroundings. b) A narrower view detailing the surroundings. The destroyed structure is surrounded by unburned grass and unconsumed trees. The immediately adjacent trees were scorched and charred by the burning structure.

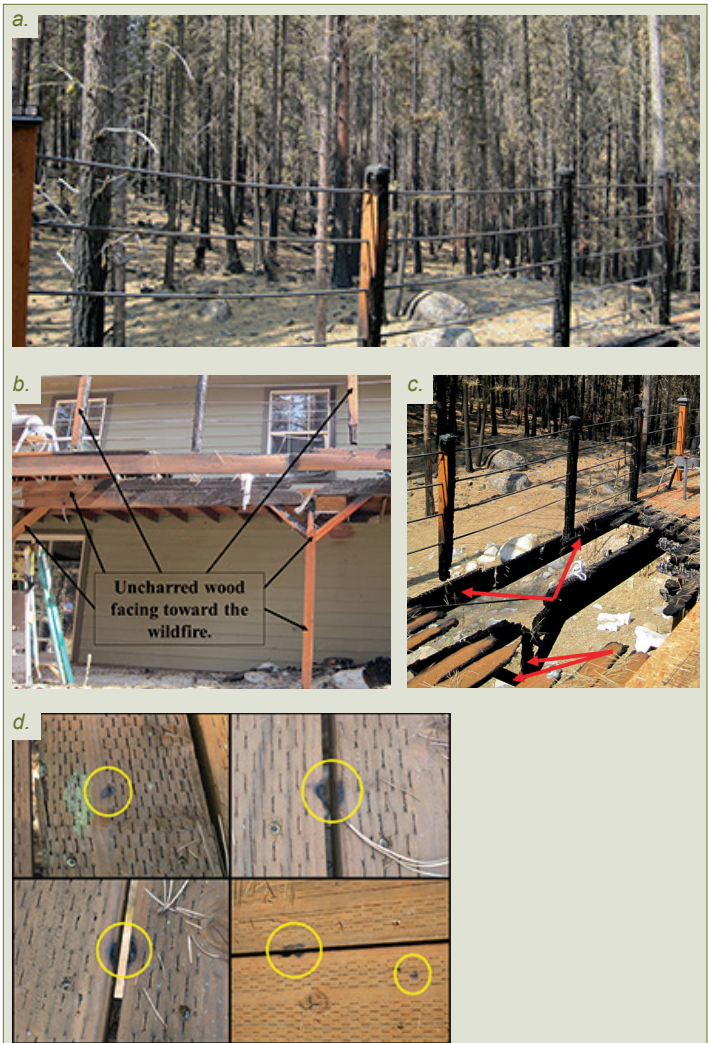
Figure 8. a) View from the burned deck at where surface fire spread to the house. No canopy fire occurred in the area immediately surrounding the house. Forest thinning and fuel treatment had not been done. b) Uncharred deck members on the sides facing the wildfire (black arrows). c) View of a portion of the burned deck (sheet of OSB covers burned-out gap in the lower right corner). The facing board and deck post sides are charred and had been burning (red arrows). d) Examples of the many firebrand char marks on the deck.

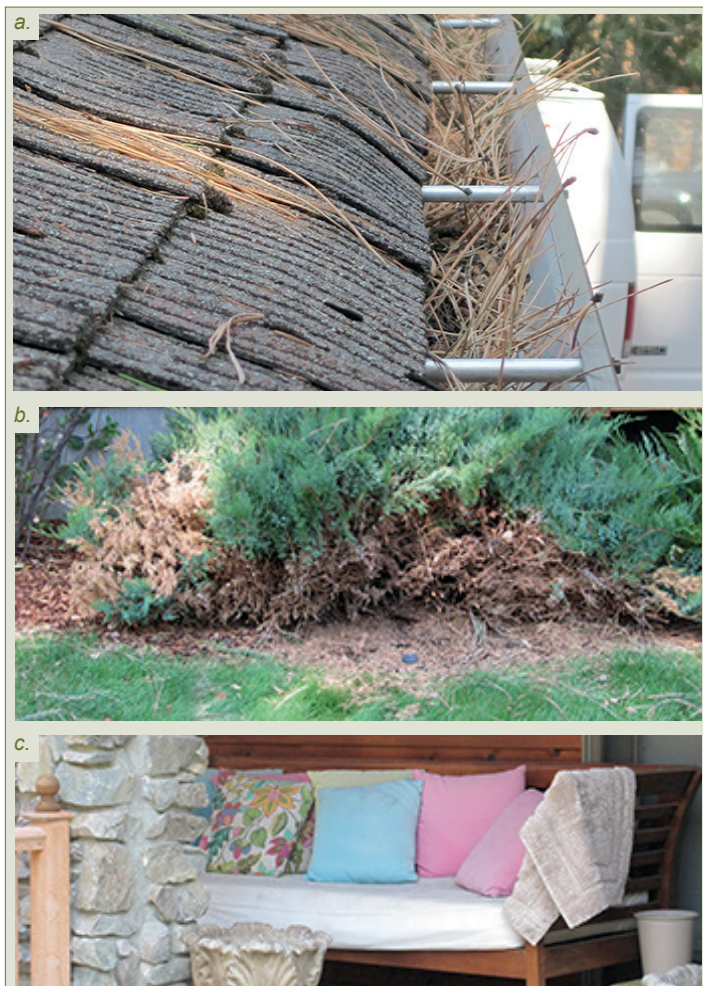
Figure 9. Example firebrand ignition vulnerabilities of houses. a) Burning dead pine needles in the rain gutter can ignite the house at the eave. b) Burning evergreen shrub from ignited dense dead material inside produces structure flame contact on the wall and under the “push-out.” c) Flammable patio furniture cushions and pillows can burn to produce flame contact with the wall and fracture windows that collapse to allow firebrands and flames to penetrate the interior.
