Missoula-Granite PMR, MAS No. 2019-02 Structure Survey Report

Montana Department of Natural Resources and Conservation (DNRC)
May 27, 2020

Prepared for:
**State of Montana, Department of
Natural Resources and Conservation**
1424 9th Avenue
Helena, Montana 59620-1601

Prepared by:
Pioneer Technical Services, Inc.
106 Pronghorn Trail
Suite A
Bozeman, Montana 59718

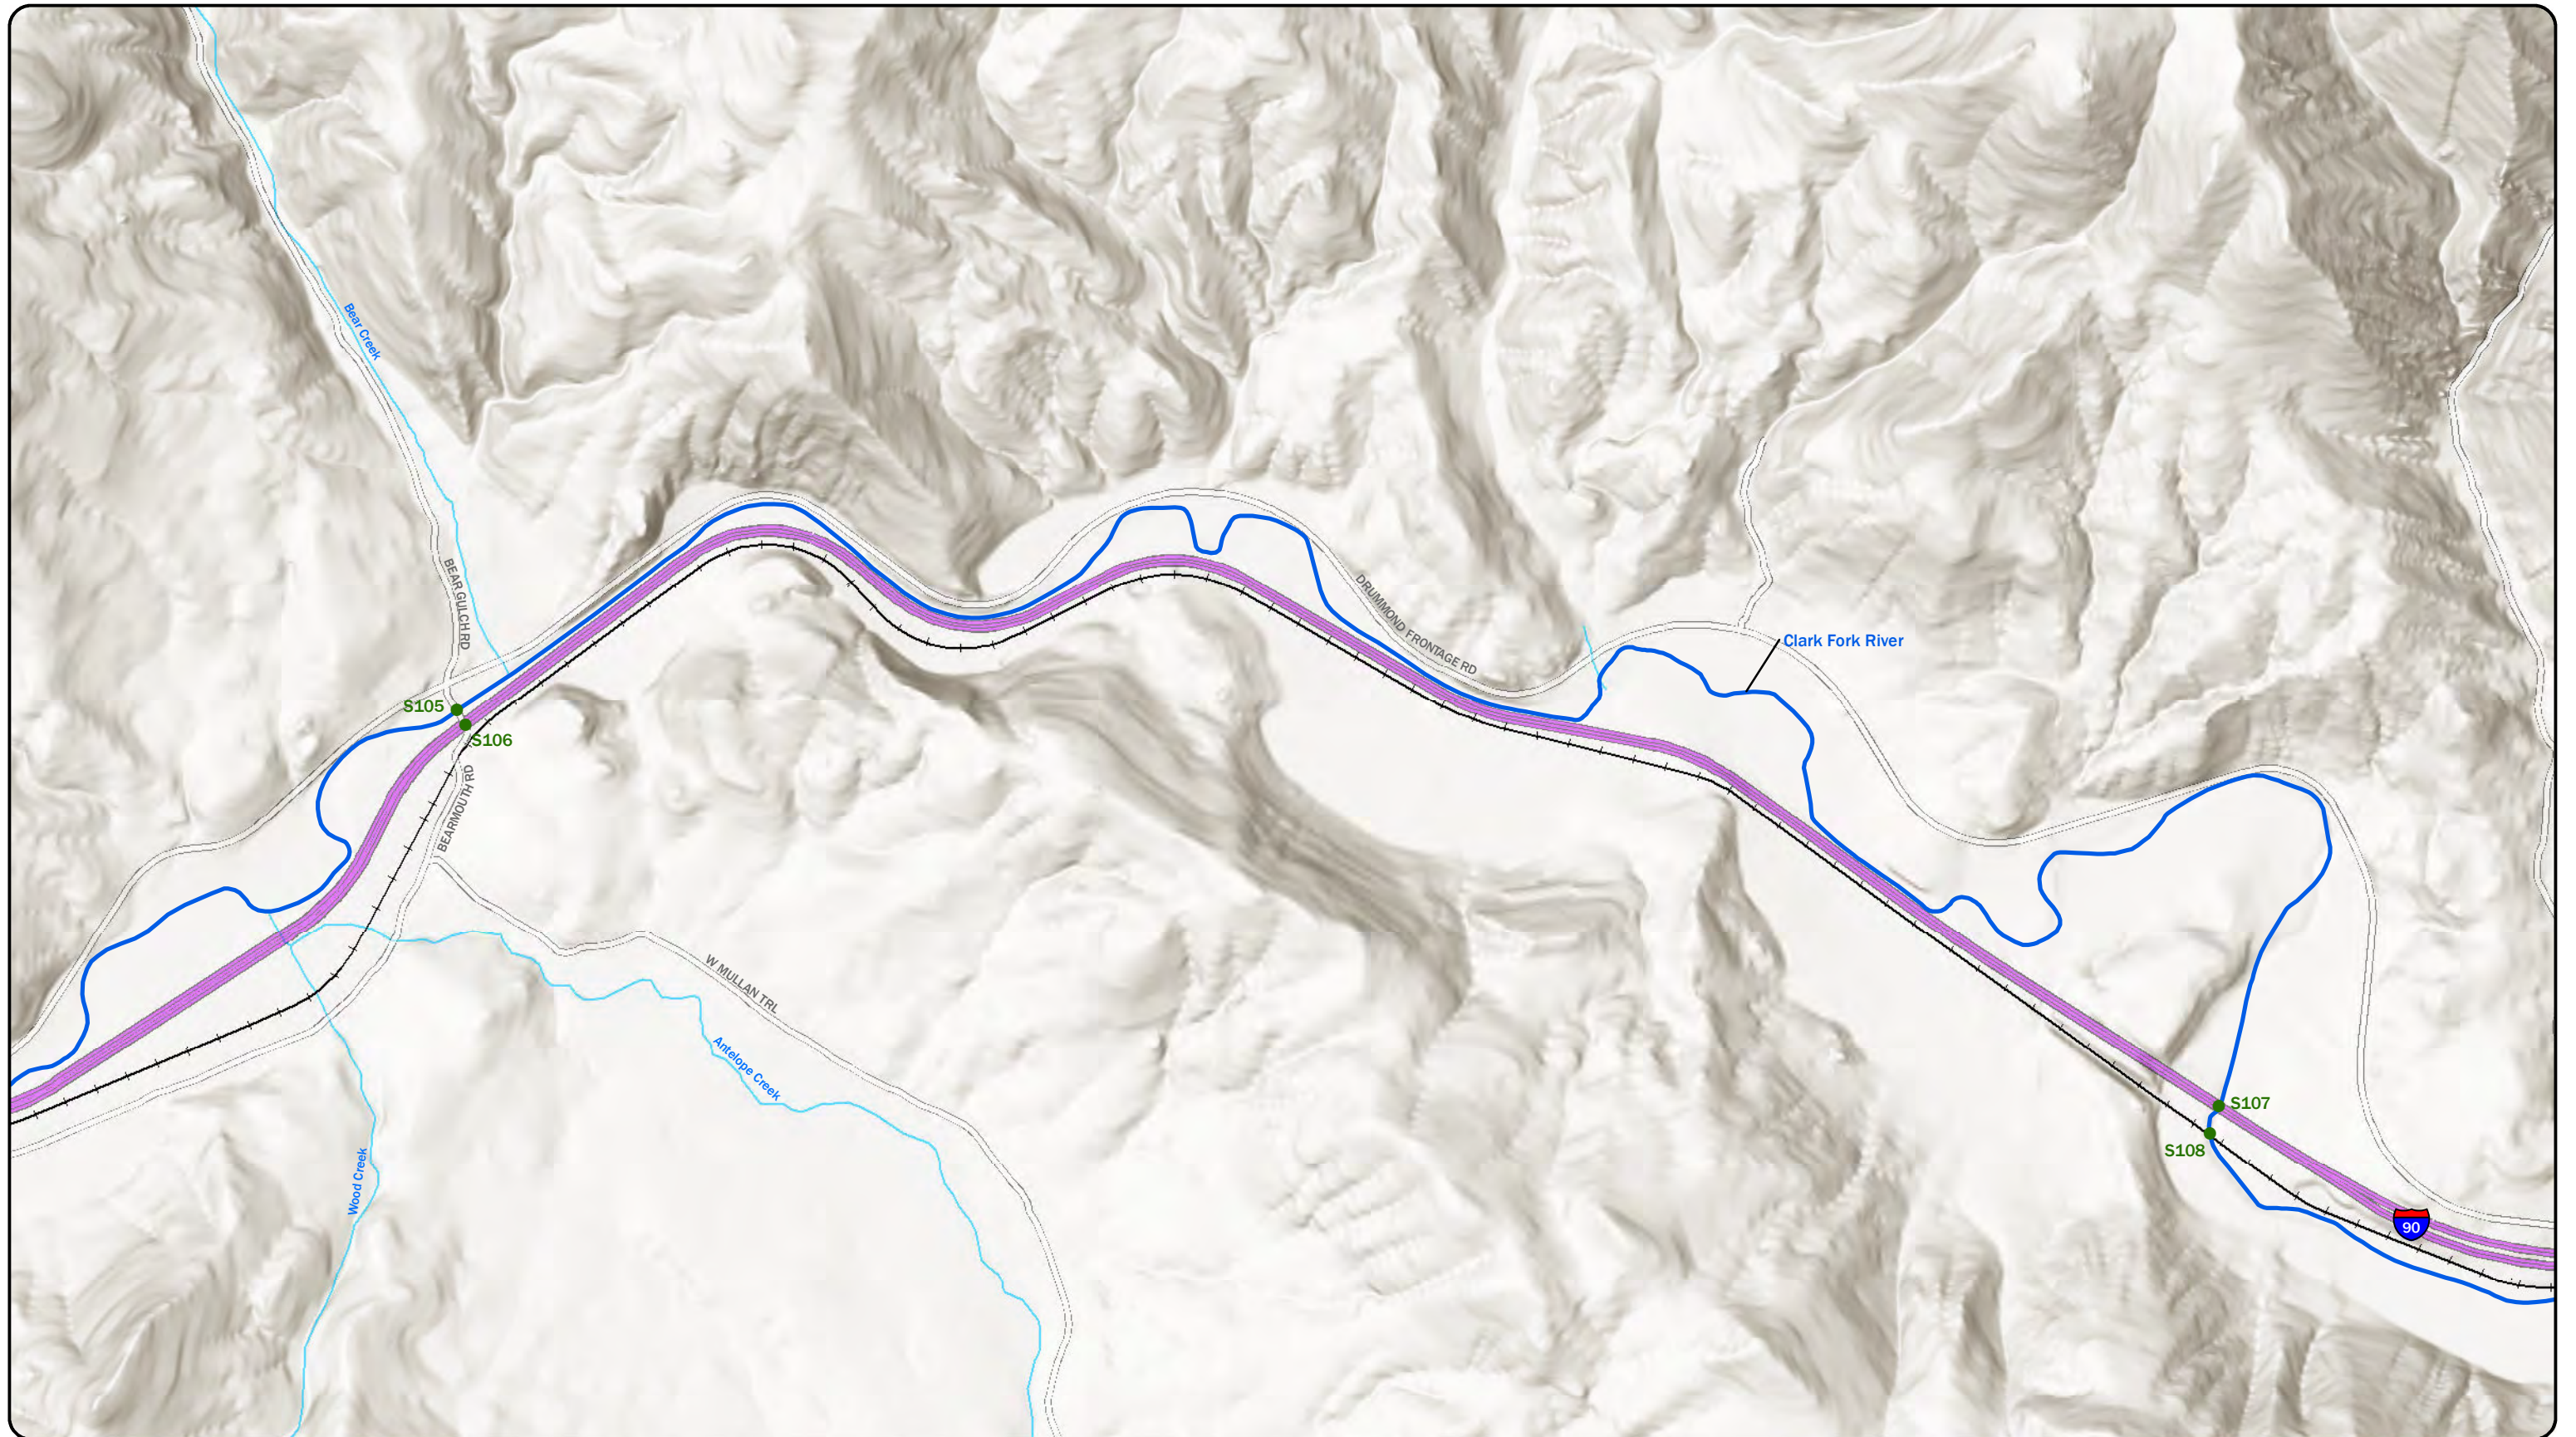
FIGURE 13

**DETAILED SURVEY
STRUCTURE LOCATIONS
S105 TO S108**

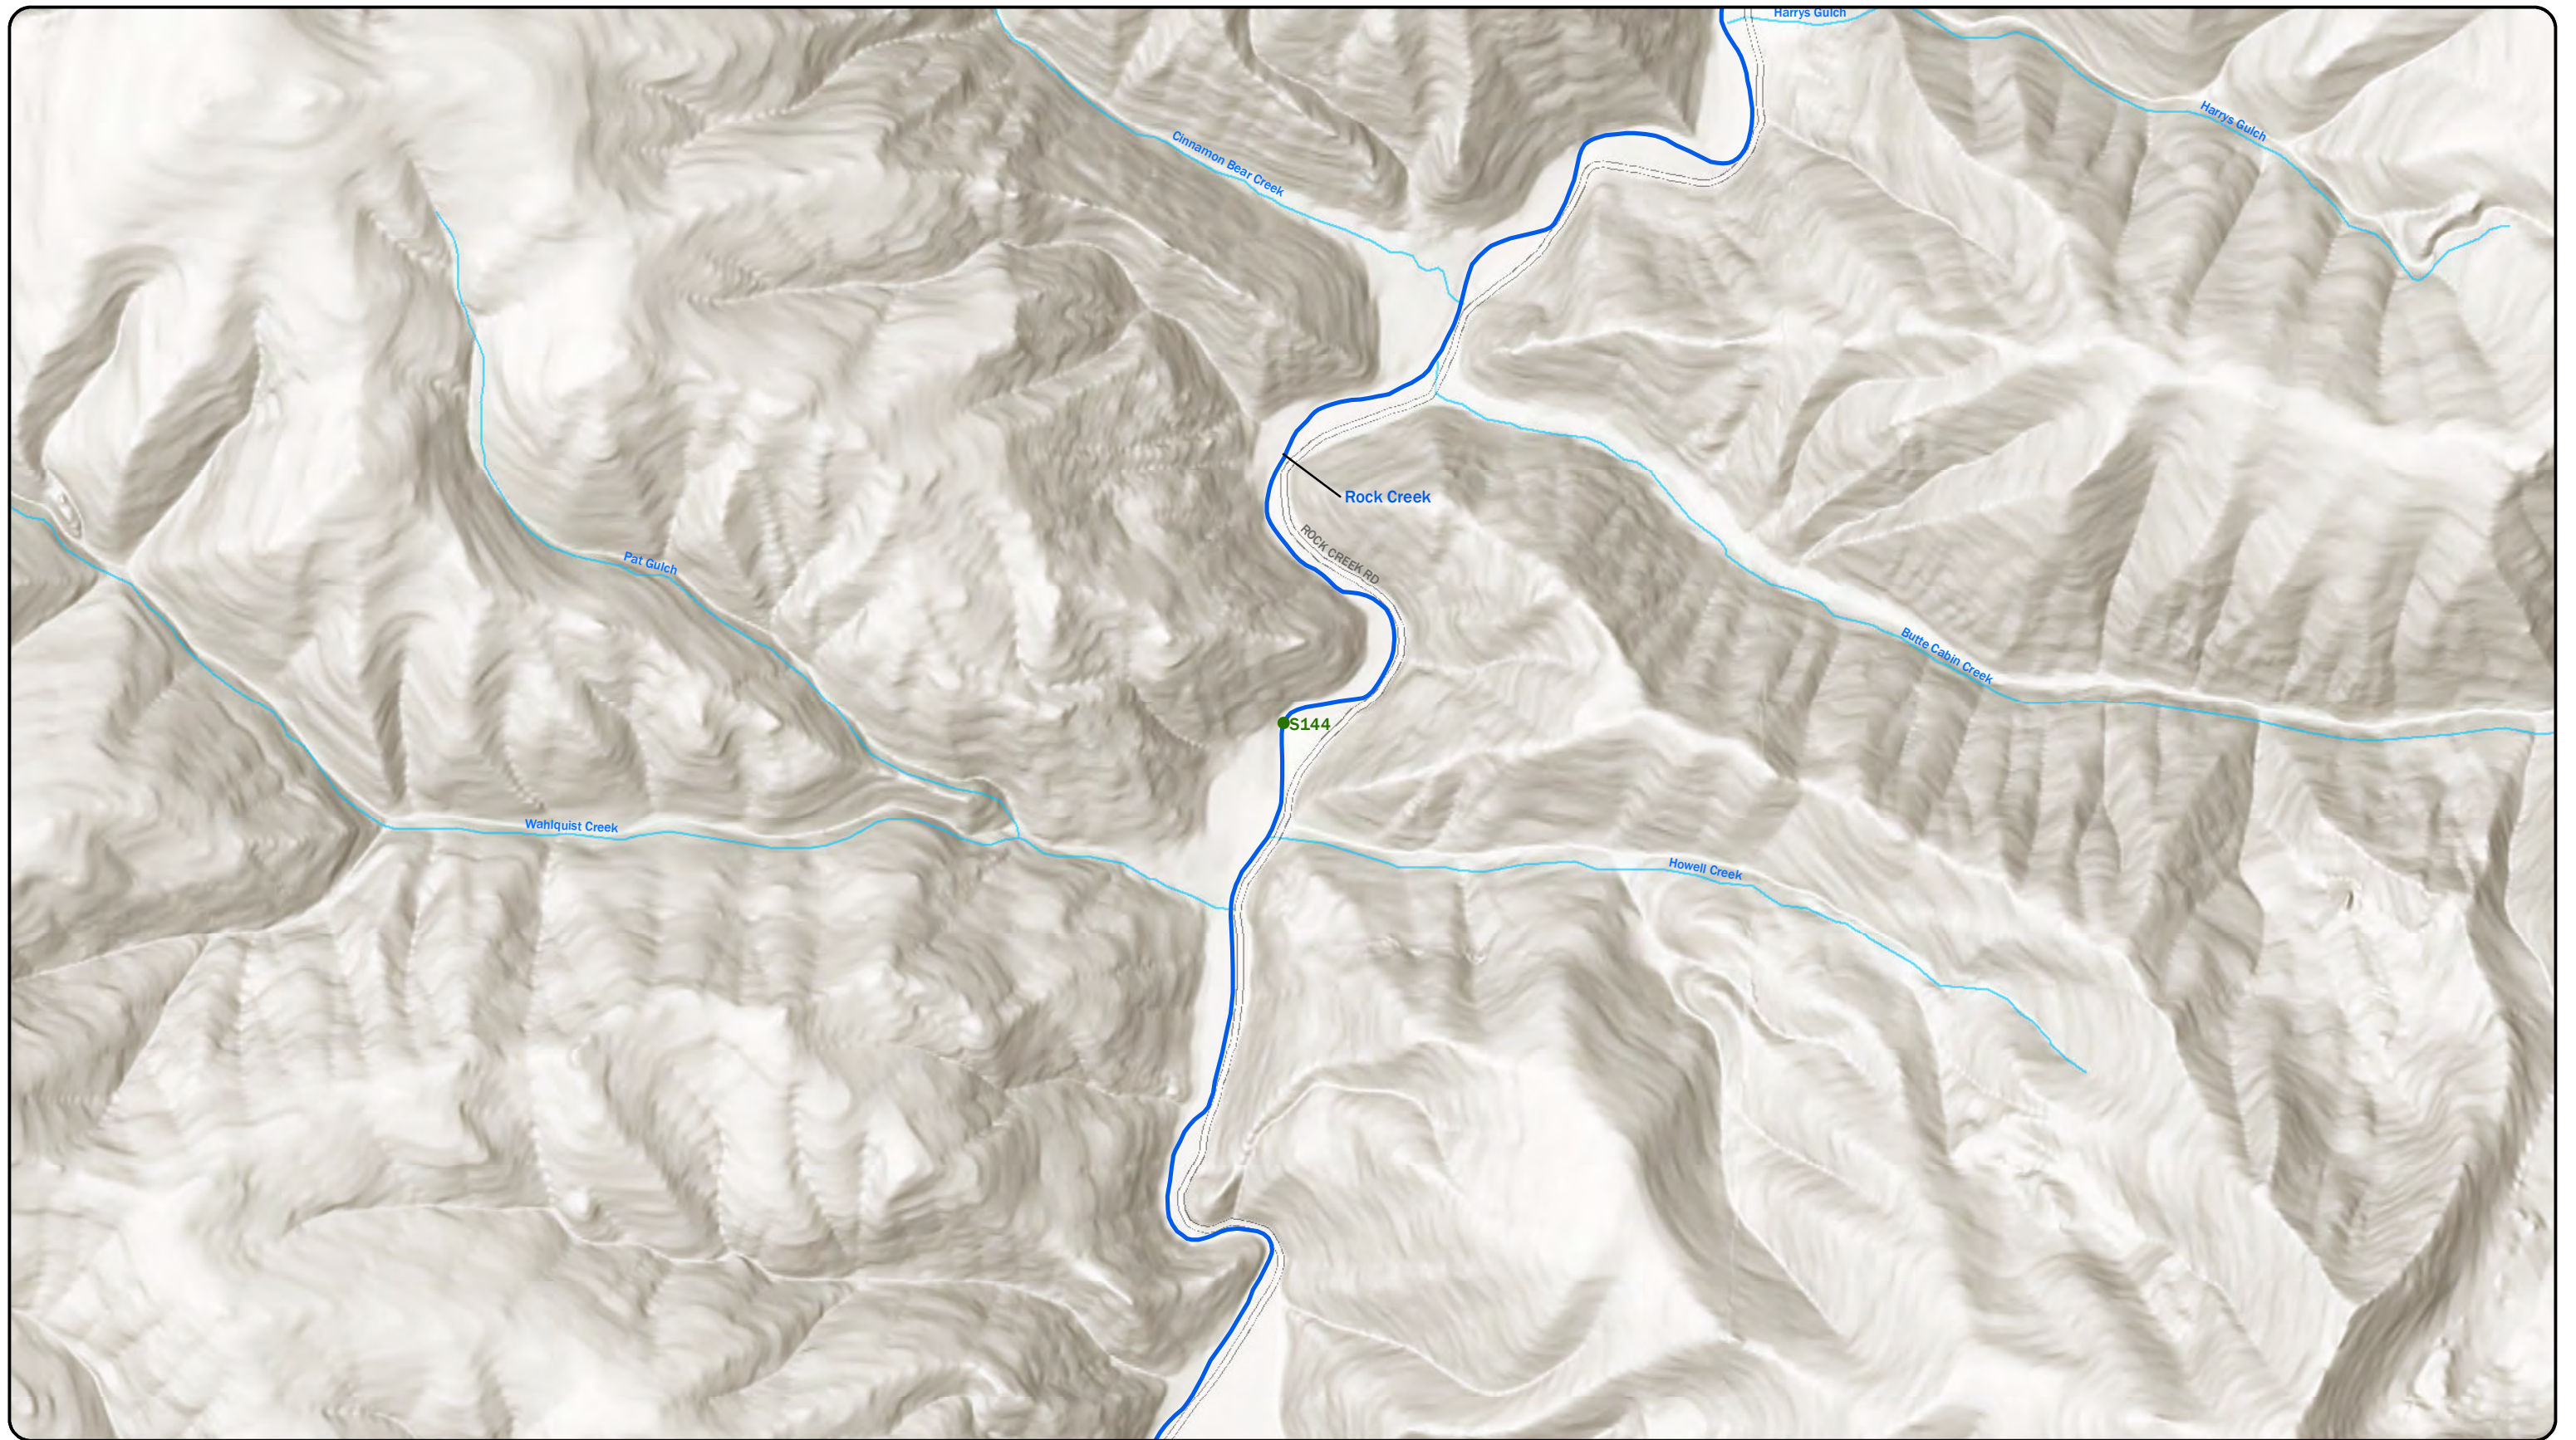
FIGURE 19
DETAILED SURVEY
STRUCTURE LOCATIONS
S144
 DATE: 5/27/2020

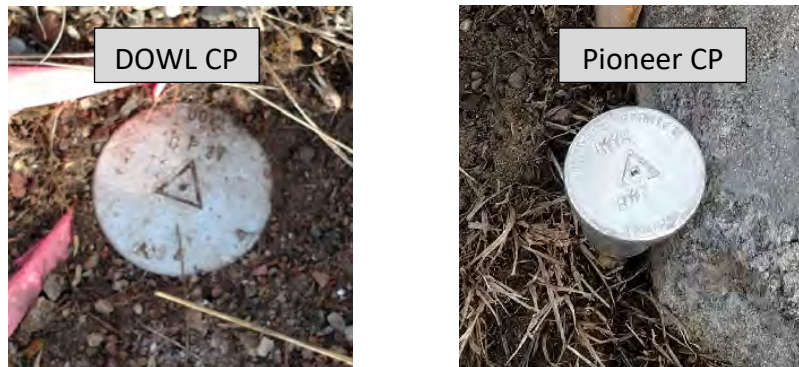
Pioneer's survey control point was marked with an 18-inch spike and topped with a 2-inch aluminum cap. Figure 21 shows an example of a typical monument set by DOWL and Pioneer.

Figure 21 Typical Control Monuments Used

DOWL used 3 QSI control points and established 32 additional survey control points to support bathymetric survey data collection in Granite and Missoula Counties. The 32 DOWL control points were marked using a 5/8-inch by 24-inch rebar with a 2-inch aluminum cap. The DOWL control points were established using 1 or more, 2-hour or longer static observations from CORS MSOL and MTUM.
