# Lower Wise River Water Resources Investigation

September 26, 2013

Big Hole River Watershed, Montana

Big Hole Watershed Committee

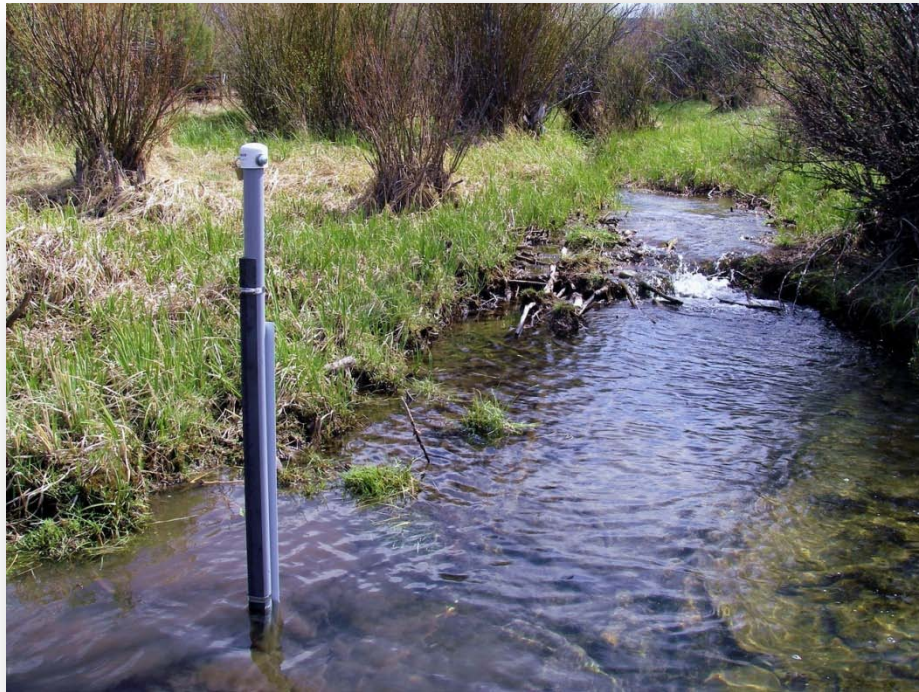
**Figure 1: TruTrack water level recorder installed in Smart Creek**

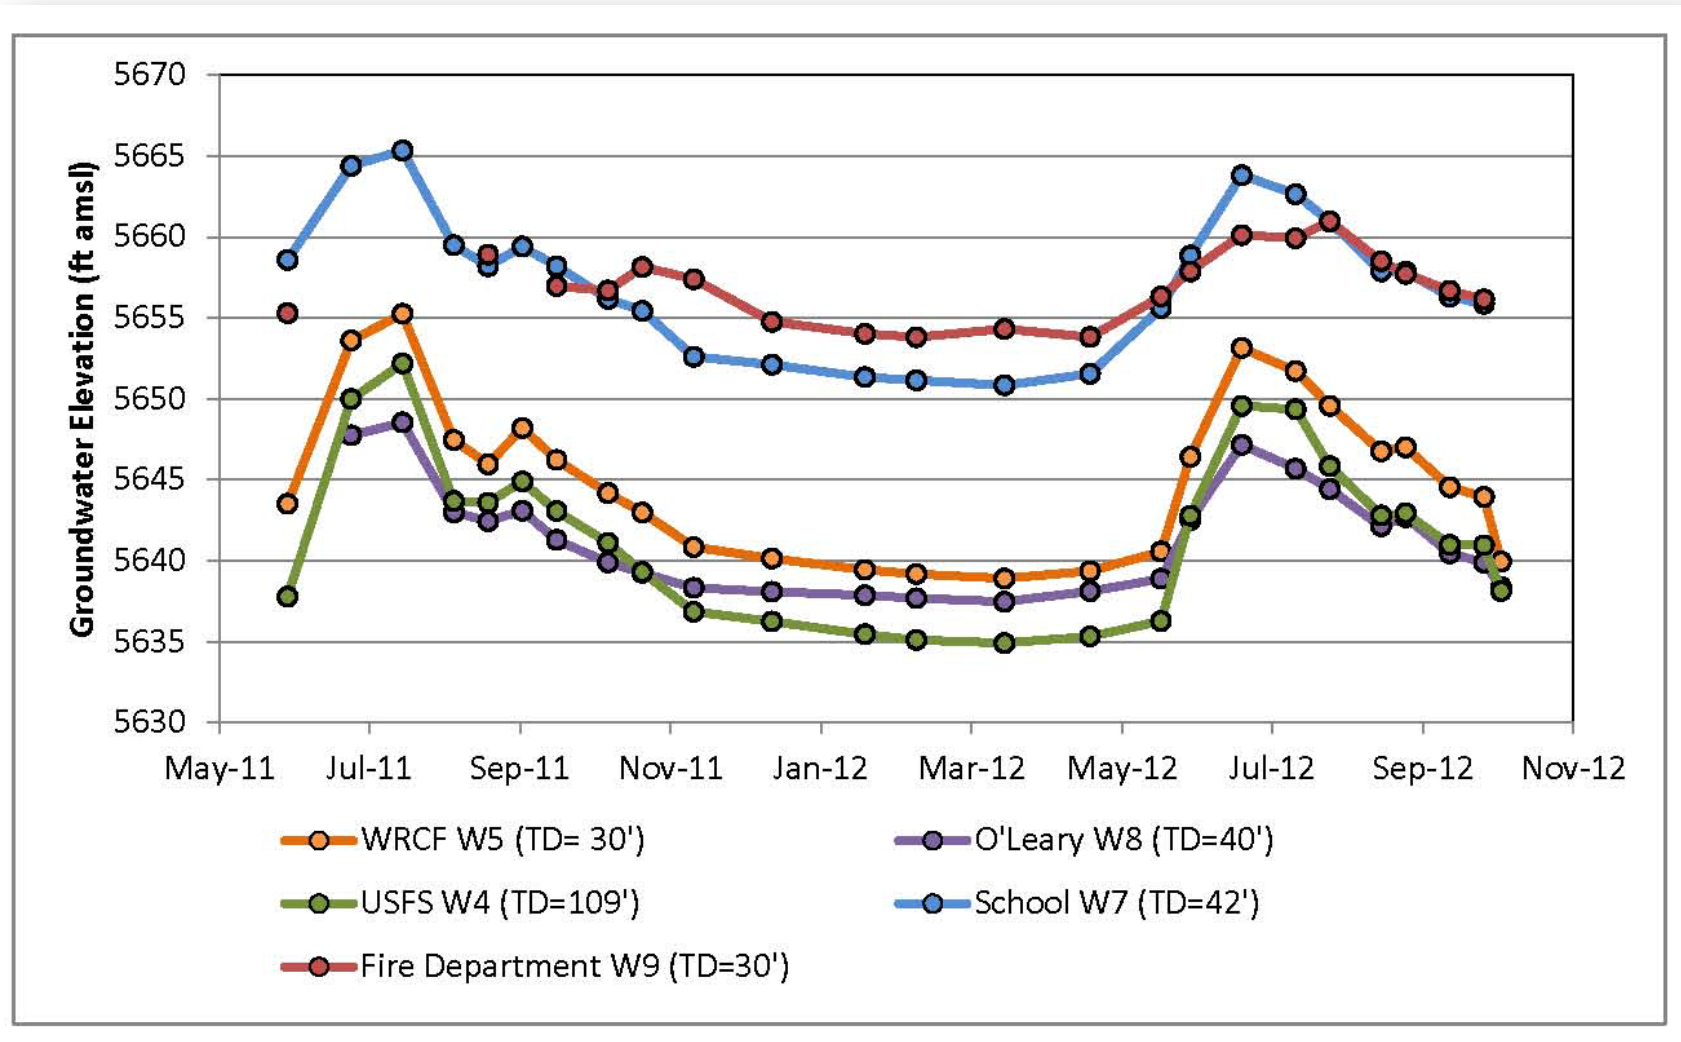
Figure 2: Representative hydrographs show that groundwater elevations typically are higher in the late spring/early fall and then decrease through fall/winter. All displayed wells were located in Pleistocene glacial outwash (Qo).

**Table 13**). Groundwater trends were similar in all monitoring wells during the period of record. Select hydrographs are shown in **Figure 2** and the rest of the hydrographs are included in **Figure 25**. Annual groundwater-level fluctuations ranged between 7 and 32 feet with an average fluctuation of 16 feet. No spatial trend is apparent in these fluctuations; rather they appear to reflect local responses to seasonal recharge and discharge stresses.

Groundwater levels rose in late spring and early summer and peaked during mid-June to mid-July in 2011 and 2012. The rise in groundwater levels appears to be primarily due to snowmelt in the spring and irrigation water that recharges the groundwater system. Groundwater recharge from irrigation is well documented (G. Abdo, Butler, J., Myse, T., Wheaton, J., Snyder, D., Metesh, J. and G. Shaw, 2013). Groundwater levels declined through the rest of the summer into the late fall/early winter when they reached base level with the exception of short rise in the fall during fall irrigation. Groundwater levels probably declined in response to decreasing irrigation applications, high transpiration, and low precipitation during the late summer and early fall months.

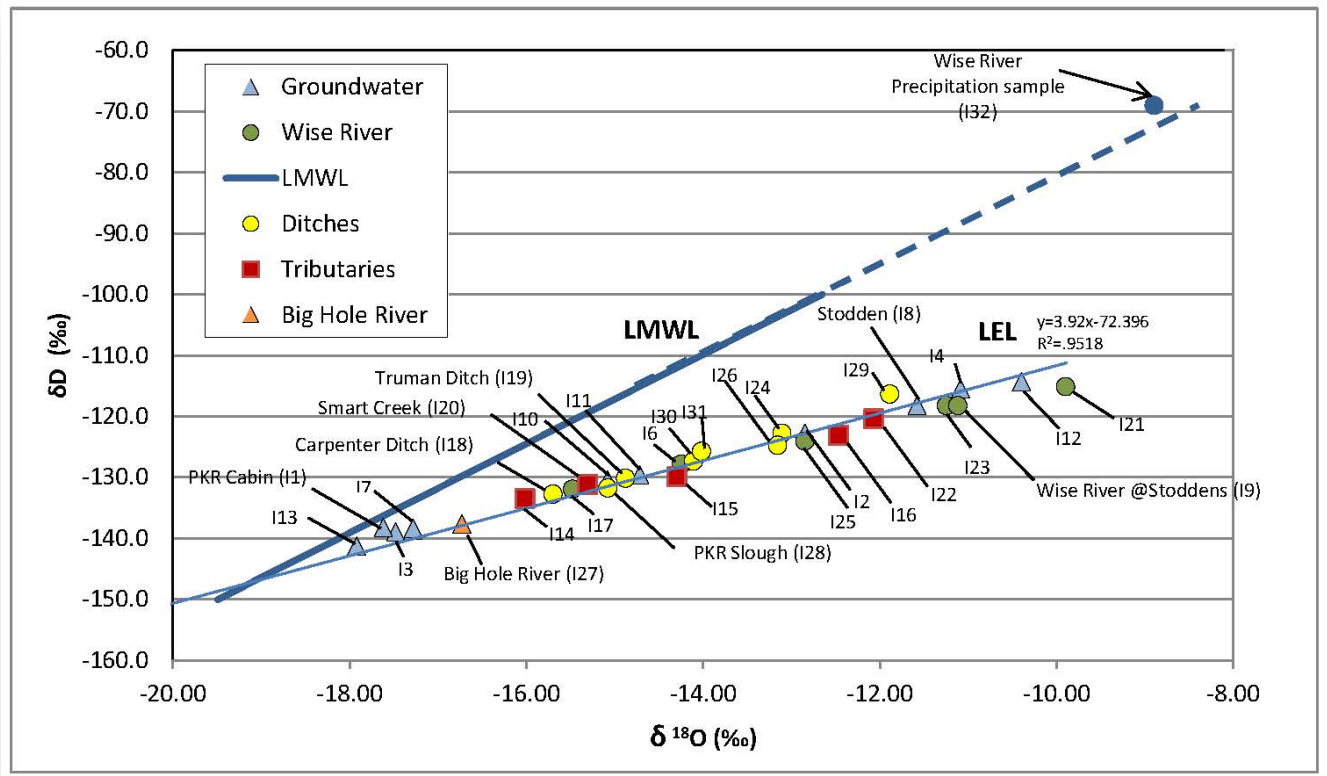
Figure 5: Groundwater and surface water are more isotopically enriched at some locations. All samples plot along the same general trend line indicating that the source for groundwater and surface water is the same. Refer to Figure 20 and Table 10 for information about points. Local Meteoric Water Line (LMWL) (Gammons, C., S. Poulson, D. Pellicori, P. Reed, A. Roesler, and E. Petrescu, 2006).

Stable isotopes of oxygen and deuterium ( $^{18}\text{O}$  and  $\text{D}$ , or  $^2\text{H}$ ) were used to help differentiate sources of groundwater and surface water. Comparisons were made between groundwater and surface water stable isotopes and the local meteoric water line (LMWL). The LMWL was established (Gammons, C., S. Poulson, D. Pellicori, P. Reed, A. Roesler, and E. Petrescu, 2006) using precipitation data for Butte, Montana (Figure 5).

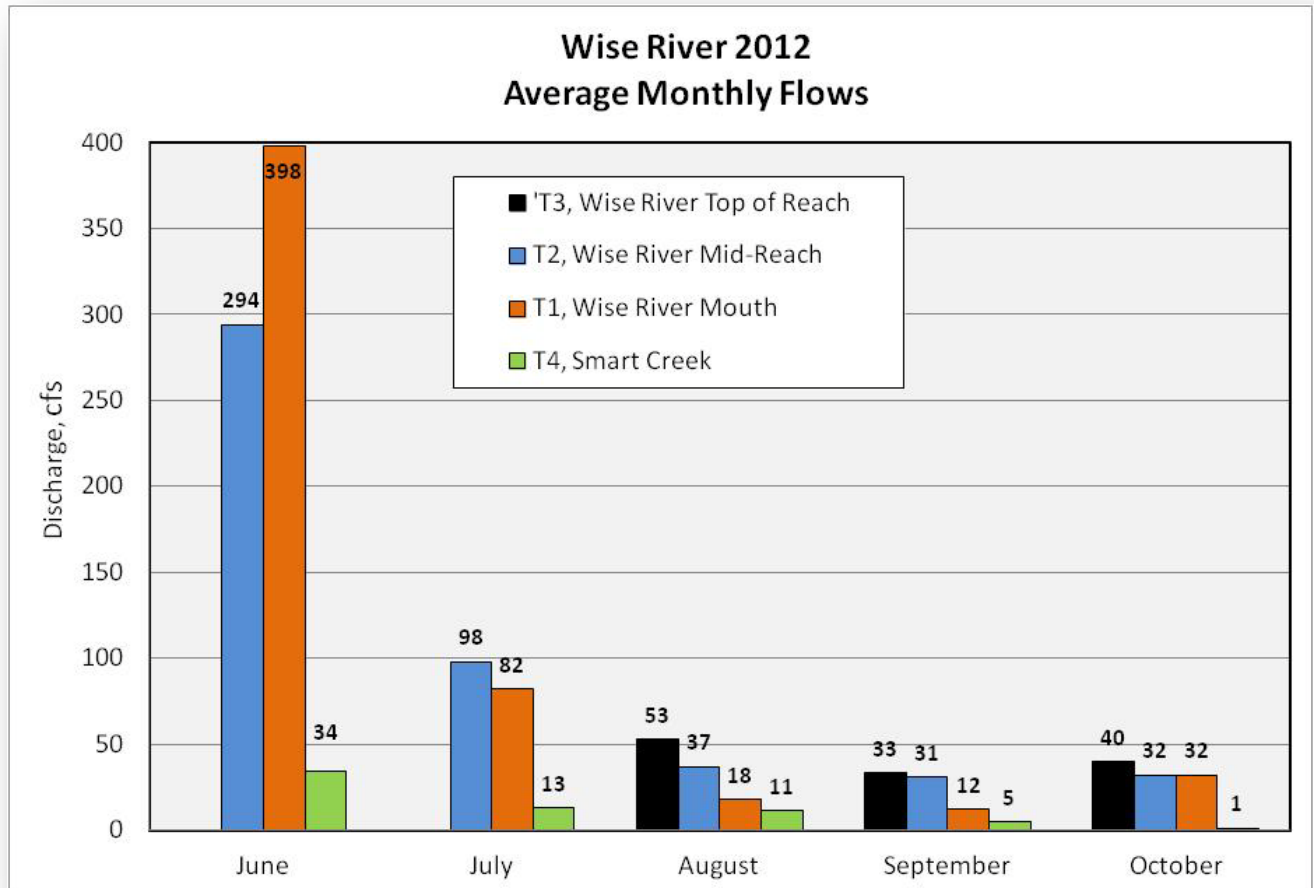
Figure 7: Average monthly flows at three Wise River Gages and Smart Creek. The comparison includes the Wise3 average monthly flows augmented with the estimated Sheep Creek Q90 monthly flows.

Combining Sheep Creek Q90 flows to the 2012 T3 average monthly flows yields T3 total flows that closely resemble the historic USGS Q90 flows, as seen in **Figure 7**. Comparing these flows to the USGS median (Q50) data confirms that 2012 river flows at T3 or the USGS site were very low. The T3 September average flow, and

several of the September daily flows, was lower than the lowest flows logged at the USGS gage over its limited period of record. Analysis of the long term USGS gage record for the Big Hole River near Melrose (USGS gage 06025500) reveals that the August and September 2012 monthly flows for the Big Hole River were at about the 80% exceedance level.

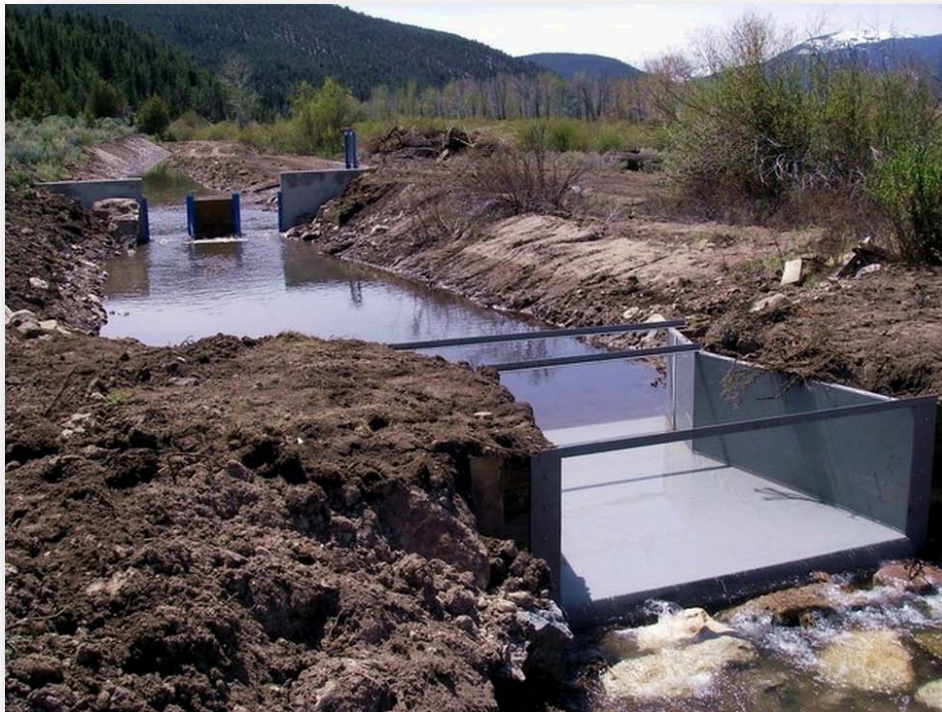
Figure 14: Upper PKR Ditch improvements include a Cutthroat Flume and a screw-gate turnout at Swamp Creek. (photo by D. Amman)

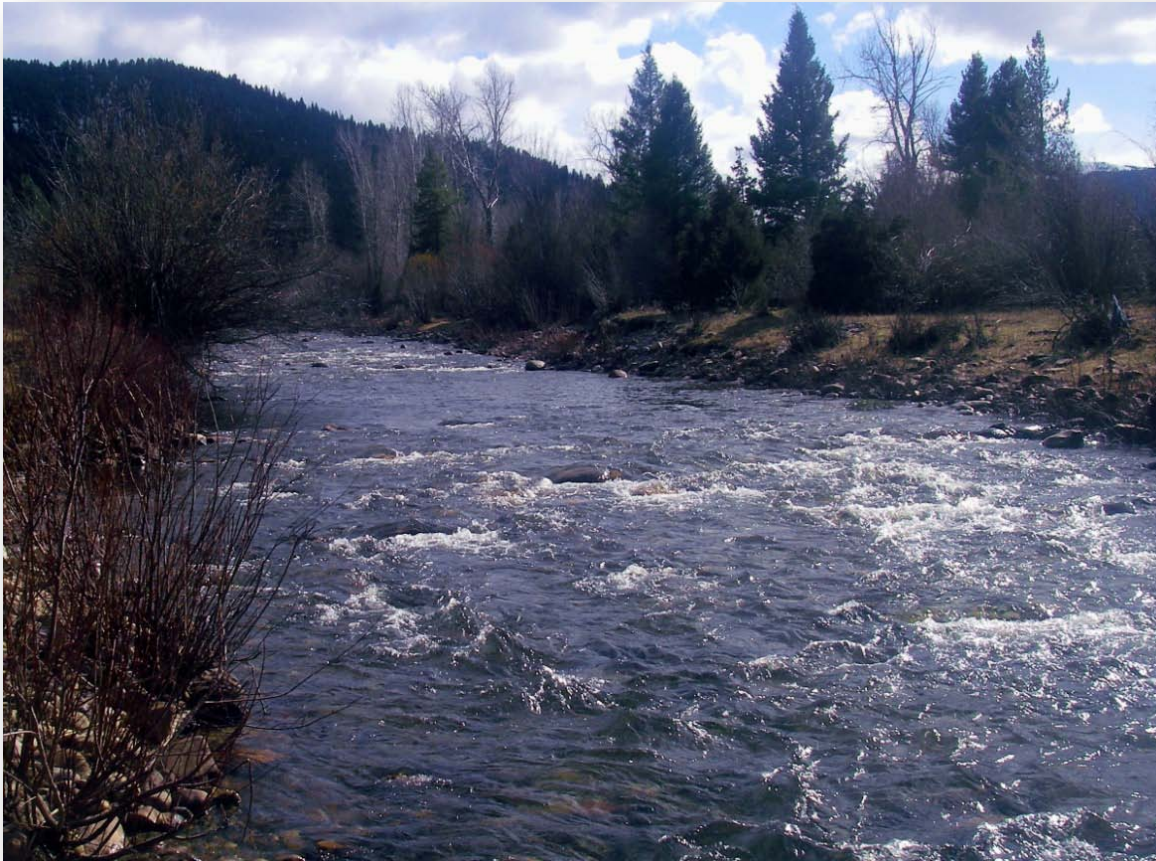
**Figure 15: Wise River just above Upper PKR headgate. (photo by D. Amman)**

A major goal of the Wise River Water Management Project was to combine flow from four individual ditches into one larger ditch (the Upper PKR). Synoptic measurement of the individual ditches was not possible before construction was completed. However, it is reasonable to assume that combining the flows into one larger, relatively sound ditch with low seepage rate increases efficiency, reduces the amount of water lost to leakage and evapotranspiration, and limits heating of the water. Estimated water savings as a result of this project are 3-8 cfs, assuming the four other ditches had loss rates similar to that of the Upper PKR ditch (2 cfs or 18% of total ditch flow). Given flows in the lower Wise River (T1) in late July and August 2012 were less than 10 cfs, these instream water savings could constitute a considerable source of water for the lower Wise River.
